## SEISMIC AND TRANSPORTATION TESTS

## ELECTRICAL PANEL YESPAN ELEKTRIK

### QUALIFICATION REPORT

RAT-MTL-ELE23-072-R00

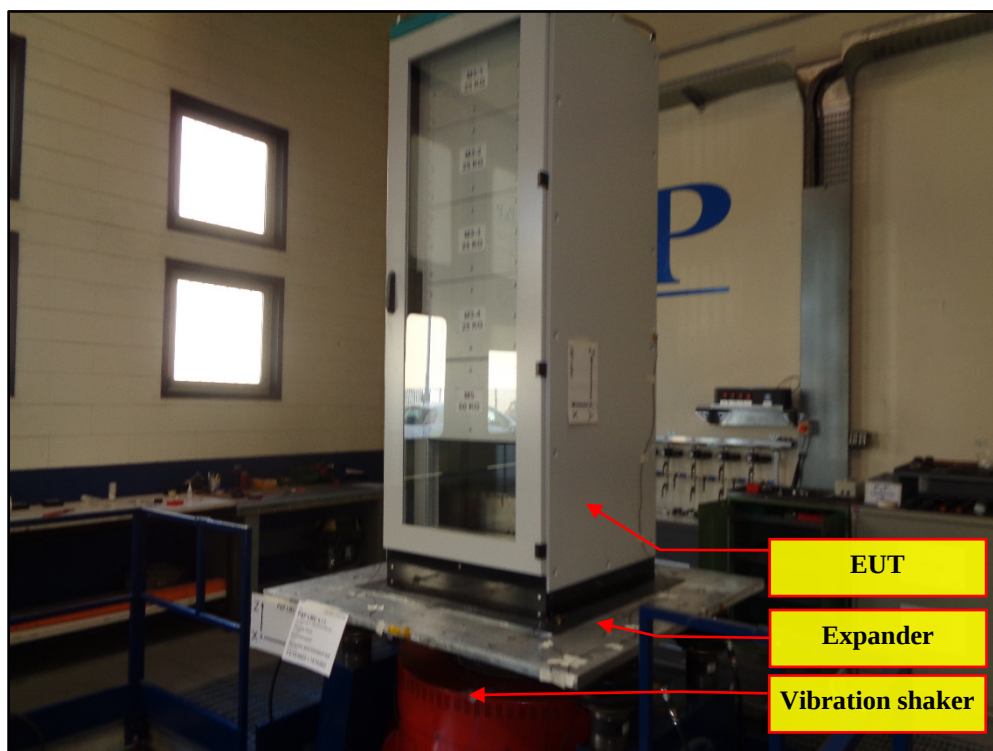
Photo 8 – Mounting technique – Z direction configuration

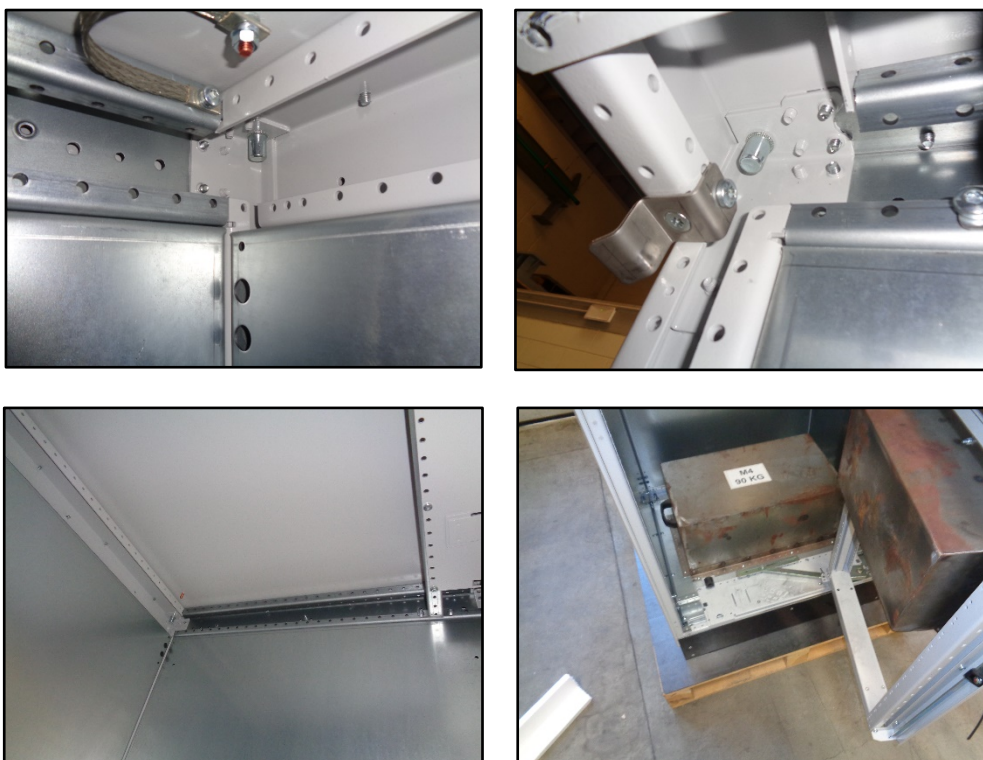
Photo 14 – Visual inspection after all tests
